USAAMRDL-TR-77-13

CRASHWORTHY TROOP SEAT TESTING PROGRAM

Boeing Vertol Company
P. O. Box 16858
Philadelphia, Penn. 19142

November 1977

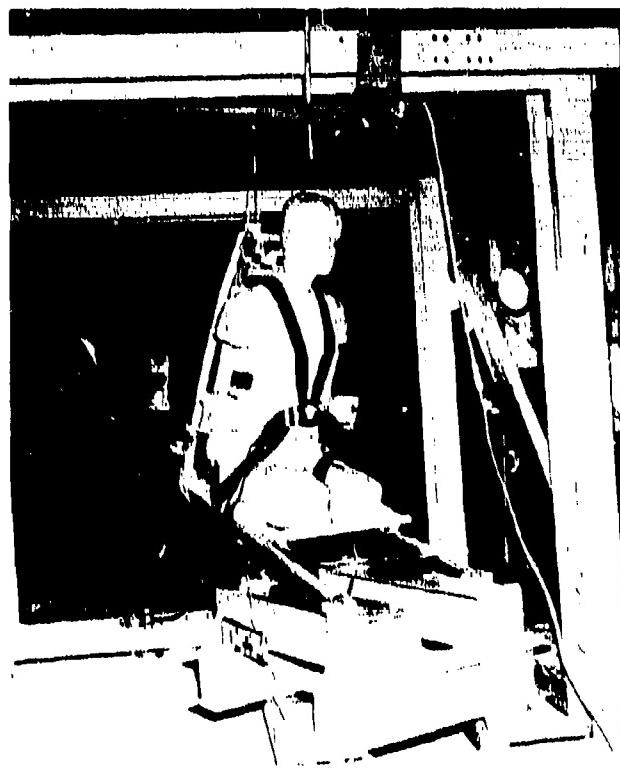
Figure 41. Post-test seat condition.

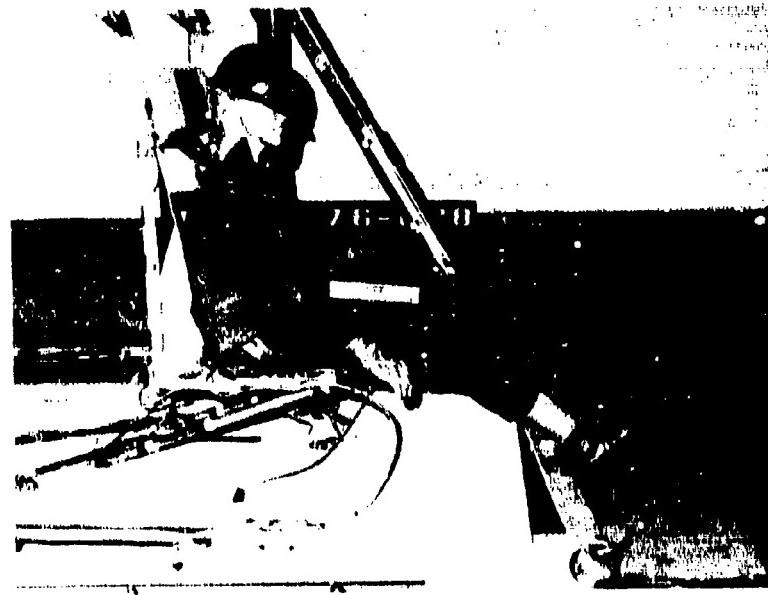
A visual inspection of the seat was made after the test and no structural or fabric damage was detected (Figure 73). A review of the motion picture film showed that the dummy was retained in a proper position throughout the seat stroking sequence. The seat deflected 30 degrees to the left from its original yawed position to align itself in the direction of impact. Swivel fittings at the point of attachment to the floor allowed the seat to realign itself.

Figure 73. Post-test 3A - Forward yaw loading.

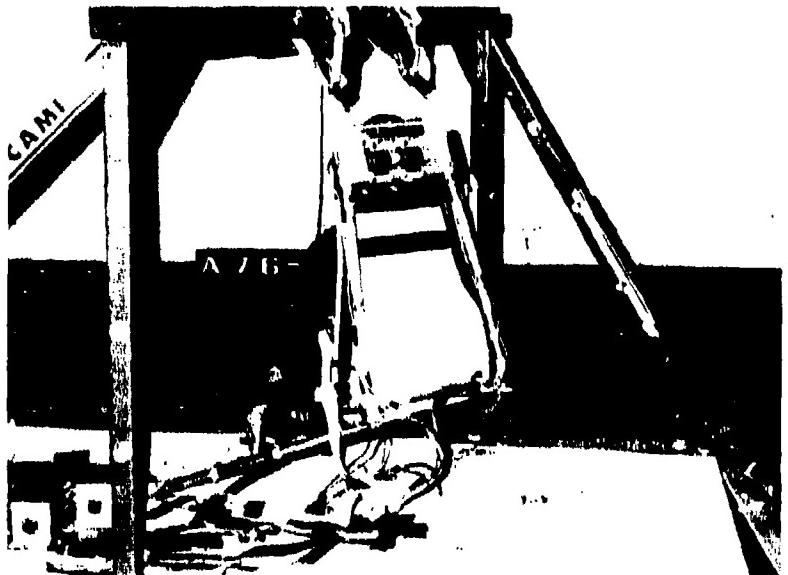
A visual inspection of the seat was made after the test and no structural or fabric damage was detected (Figure 80). However, the front diagonal cable anchor pulled out due to the use of a shear nut rather than a tension nut. A review of the motion picture film showed that the dummy was retained in a proper position throughout the seat stroking sequence. The only exception was the right arm flailing and contacting the seat back.

Figure 80. Post-test 4A - Forward yaw loading.

The test conclusions are that the seat system functioned as required. All attenuators required to stroke did stroke and reduced the accelerations on the 95th percentile occupant to well within the desired limits. These acceleration levels can be extrapolated to show that accelerations on a 5th percentile occupant would also be within limits. Replacement of the diagonal cable anchor fitting nut will prevent pullout.

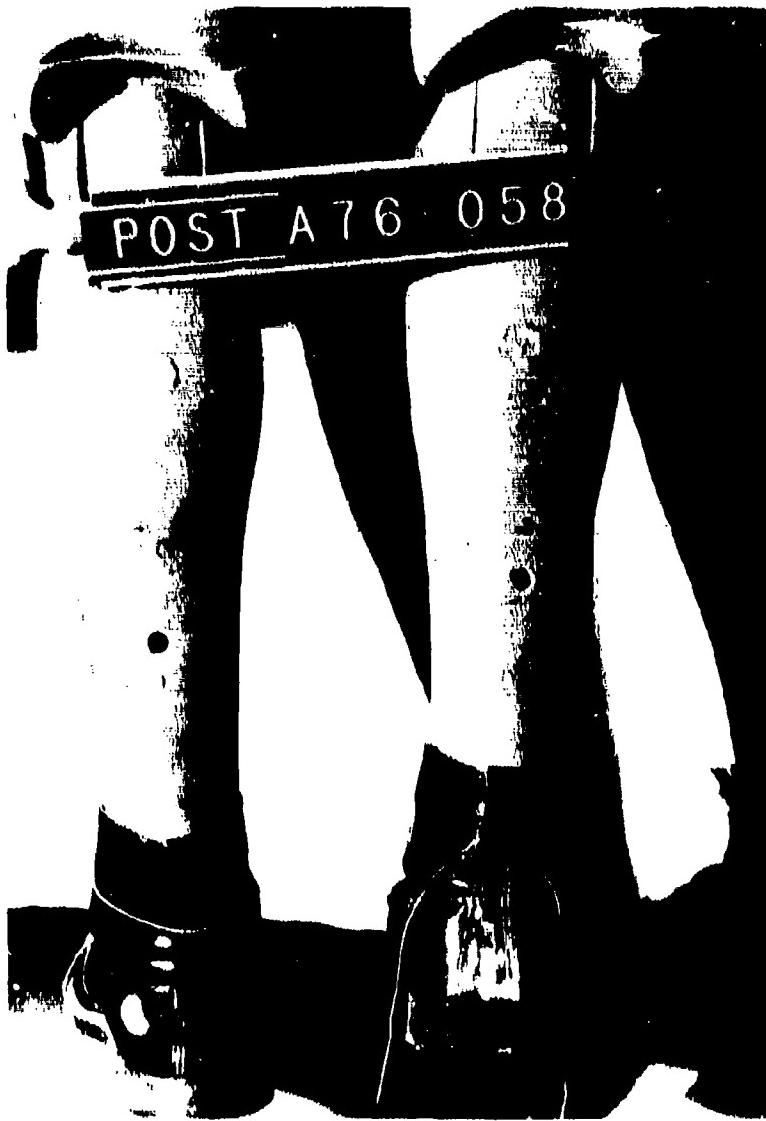
Figure 103. Seat impact with dummy's legs.

A visual inspection of the seat after the test revealed that the vertical energy attenuators had stroked only 6.1 in., a minimum stroke of 11 in. had been anticipated (Figure 102). The rear tube of the seat pan had been bowed downward 2.8 in. at the center (Figure 102). The cause of the minimum stroke was initially attributed to much of the energy being absorbed by deformation of the rear tube. However, review of the motion picture film revealed the cause of the minimal stroke. Vertical impact was simulated using a horizontal accelerator by rotating the seat 90 degrees onto its back. The legs of the dummy were held up by light string; during impact the string broke, allowing the legs to fall down under the seat, thereby preventing the seat from fully stroking. The impact of the front of the seat pan on the calves of the dummy's legs was evidenced by marks (Figure 103). No other damage was detected on the seat structure or fabric.

← Impact with
dummy's legs
